**P**reliminary  
**T**echnical  
**A**ssessment

**ROMAN CITY OF SISCIA  
Sisak  
CROATIA**

Integrated Rehabilitation  
Project Plan  
Survey of the Architectural  
and Archaeological Heritage

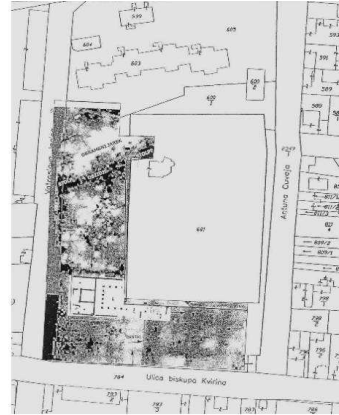
St. Kvirin site, geophysical research, 2003

Geophysical research of the whole site of Roman Siscia is planned with the intention of getting insight into the inaccessible structures beneath the town streets and squares and a clearer picture of the Roman urban matrix.

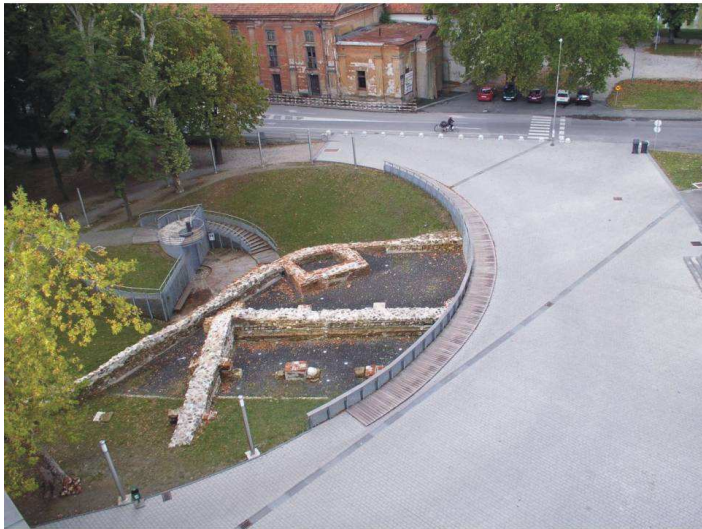
St. Križ site, presenting the city walls with the tower and horreum, 1997-2001

The St Križ site (city walls, horreum) was explored, documented and presented *in situ* in the period from 1997 to 2001.

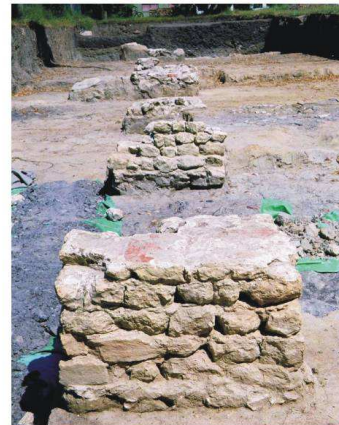
St. Kvirin site, forum, 2003

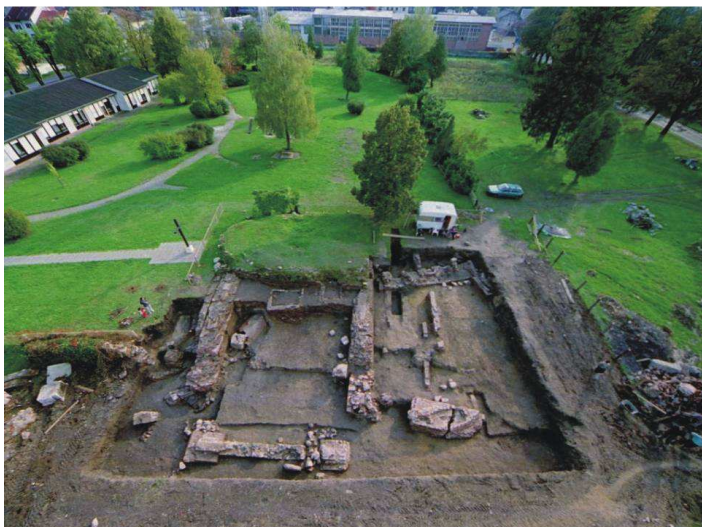
St. Kvirin site, the north town entrance 2004

- 2004-7 The north town entrance with a section of the city wall was discovered on the location of St. Kvirin. The site is protected by a new enclosure.
